Manhole Inspection Summary

Manhole # S19G__039MH

Insp Date: **10/9/07 10:36 AM**

Location Address: **113 PULASKI ST**

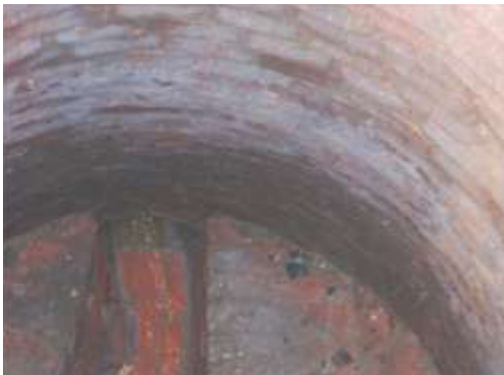
Defect 2

Infiltration: ☐ None ☐ Joint ☐ Cracks ☐ Mortar ☐ Roots ☒ **Wall**

BARREL INFILTRATION

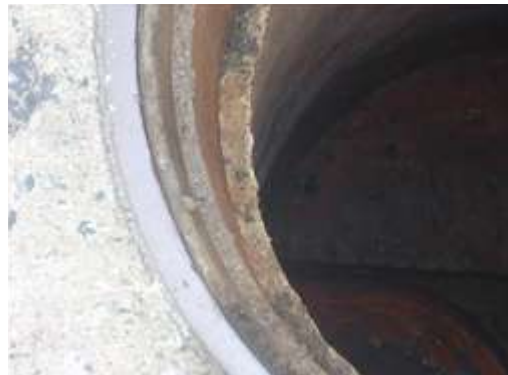
Defect 1

Frame Offset: **1** (in.) Condition: ☒ Sound ☐ Cracked ☐ Leaks

FRAME OFFSET

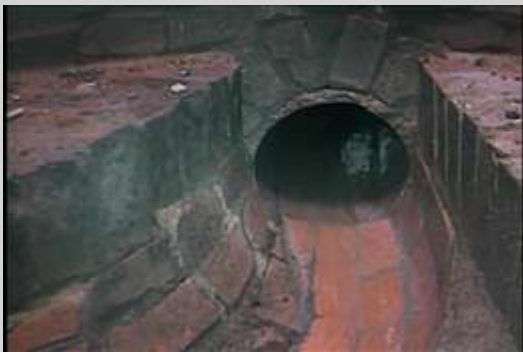
12 O'Clock Outflow

8 in. Circular Gravity Sewer
Pipe Out @ 12 O'Clock

Pipe Height: **7.2** (in.) Rod and Bar (Angled)
Pipe Material: **Clay** ☐ Pipe Lined
Invert Depth: **8.80** (ft.) Flow Characteristics: **Fast**
Deposits: ☒ None ☐ Mud ☐ Sludge ☐ Debris ☐ Grease
Silt Depth: (in.) Deposits Extent:
Infiltration: **None** Pipe Seal Cond: **Sound**

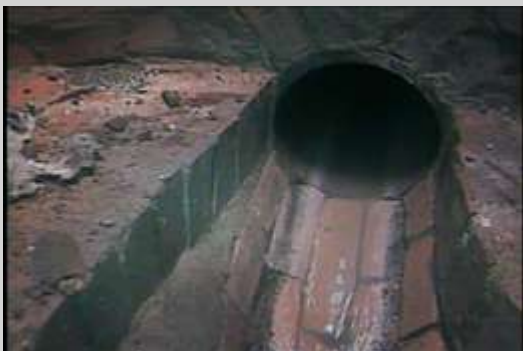
9 O'Clock Inflow

8 in. Circular Gravity Sewer
Pipe In @ 9 O'Clock

Pipe Height: **8.4** (in.) Rod and Bar (Angled)
Pipe Material: **Clay** ☐ Pipe Lined
Invert Depth: **8.20** (ft.) Flow Characteristics: **Fast**
Deposits: ☒ None ☐ Mud ☐ Sludge ☐ Debris ☐ Grease
Silt Depth: (in.) Deposits Extent:
Infiltration: **None** Pipe Seal Cond: **Sound**
